# Big Water Fire Apparatus LLC

## Annual Fire Pump Maintenance & Certification

September 1, 2022

Apparatus: 2007 International /Darley Engine #1  
Fire Pump: # 89737 PSM 1250 GPM  
Mileage: 9,502.0  
Hours: 926.0 TRK# 062736  
VIN: 1HTWDAZR98J568066

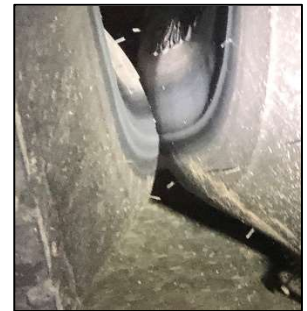
- \* Windshield Washer Fluid low- **Fluid topped off**
- \* Anti-Freeze Fluid low- **Fluid topped off**
- \* Engine Oil- **Proper level**
- \* Alternator Belt showing signs of being frayed on the edges (**recommend replacement**)
- \* Front Slack Adjusted Pins Frozen- **Pins were freed up Pins move easily now.**
- \* Chassis was visually inspected - **All appeared in good working order.**
- \* Front Suspension was inspected - **All appeared in good working order.**
- \* Exhaust System was visually inspected - **Appears to be in good condition.**

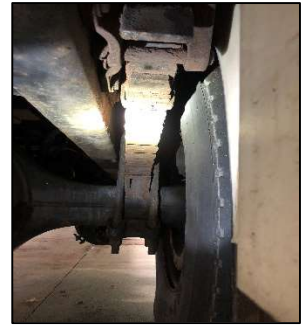
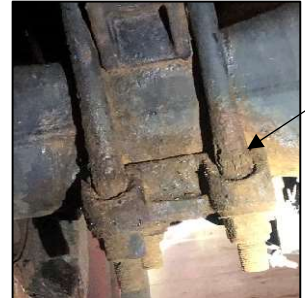
- \* Adjusted Front Brakes
- \* Rear and Front Slack Adjusters Pins Frozen- ***Pins were freed up. Pins move easily now.***
- \* Adjusted Rear Brakes
- \* Front-end tight no excessive play noted- ***Needs greasing***
- \* Rear Spring Packs- ***appears to have an outward tilt. It appears to be, that, something is not correct with the rear spring position, however, an outside heavy truck repair vendor states this is normal.***
- \* Rear U-bolts and Brackets Rusted (***recommend replacement***)
- \* Battery System Manufacture Date 7/17 Rate 700 CCA  
Tested #1 550 CCA #2 900 CCA  
All Battery Terminals were loose- ***Cleaned and Tightened***
- \* Curbside Dump Valve- ***electrical connection reconnected Valve worked correctly after repair***
- \* Fuel Injector Cleaner- ***Added***
- \* Added Shoreline Air Shut-off
- \* Added Tool Holders and Wrenches
- \* Replaced Step Light and Harness

- \* Annual Chassis Maintenance (oil and oil filter, fuel filters, chassis grease)
- \* Tire Replacement
- \* Annual Fire Pump Maintenance and Recertificating
- \* Troubleshoot CAFS lack of operations
- \* Deck Gun Ball Valve Overhaul
- \* Batteries are at 5 years old and one Battery tested low CCA (***recommend replacement***)
- \* Rear U-bolt Replacement
